## Abstract Almo Riparian Restoration Project

Carolyn Firth, Water Quality Resource Conservationist Idaho Association of Soil Conservation Districts, Burley, Idaho 1361 East 16<sup>th</sup>, Burley, Idaho 83318 Phone: 208-678-1225

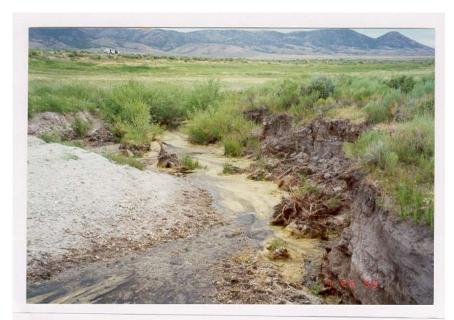
7-28-99. The stream's vertical banks (above) result in excessive sediment load. Abundant algal growth and stagnant water indicate high temperature and high nutrient content. Lack of riparian vegetation prevents streambank storage of water.

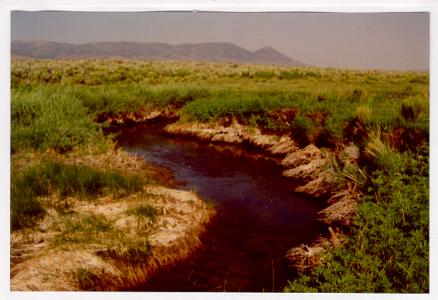
7-26-02. The tree revetments shown below are functioning as designed. The banks are becoming stable and the floodplain is widening, resulting in increased streambank storage.
